# Full Circle Climate Adaptation at Blickling Estate

Heather Jermy, General Manager

# Blickling: A Norfolk Country Estate

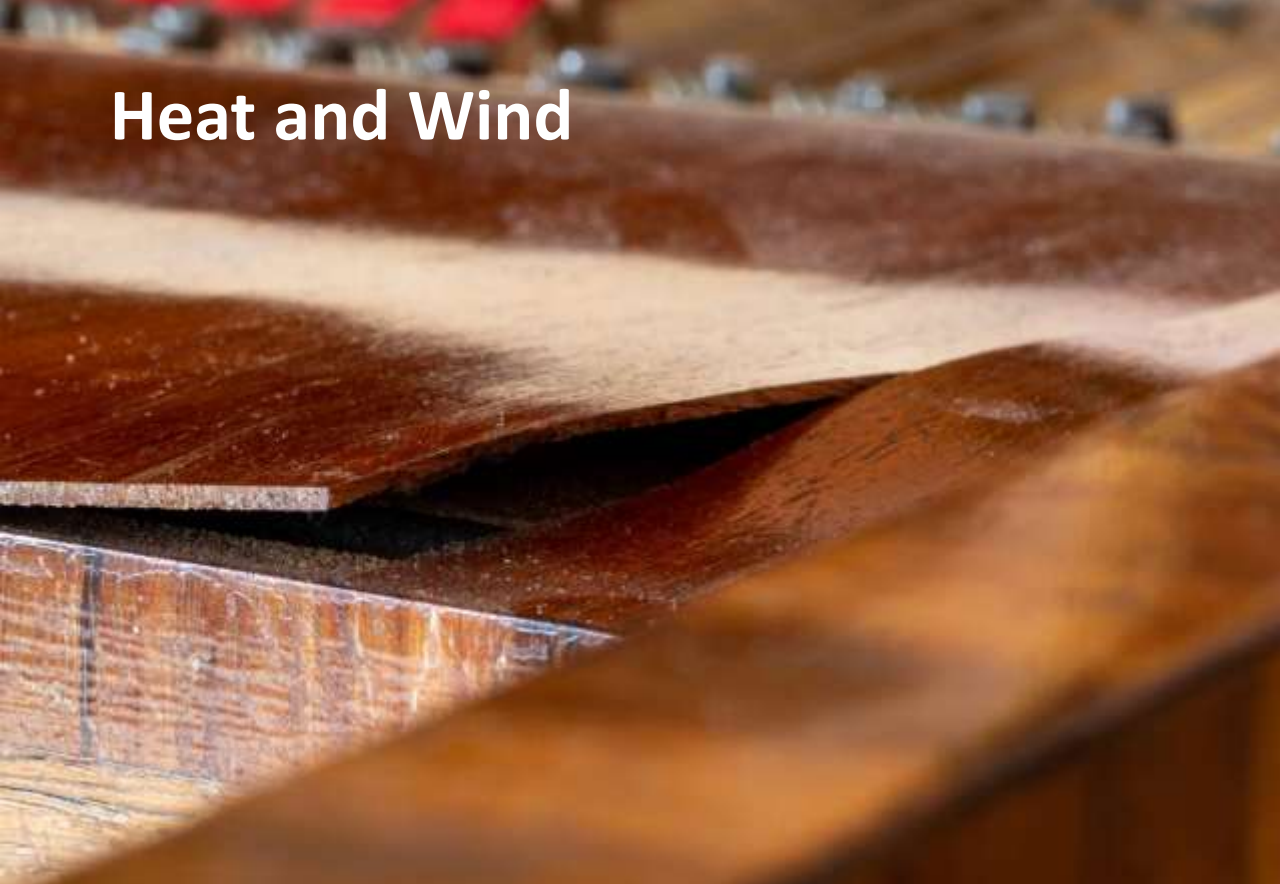
Baseline 2020

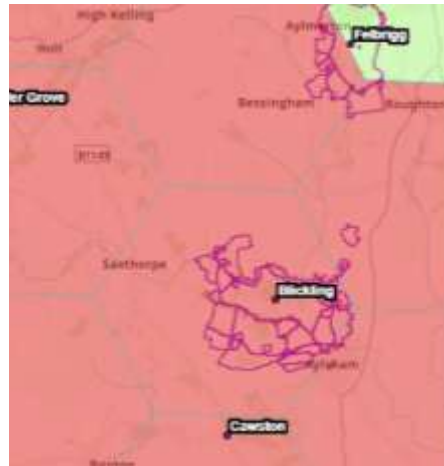
Predictions 2060

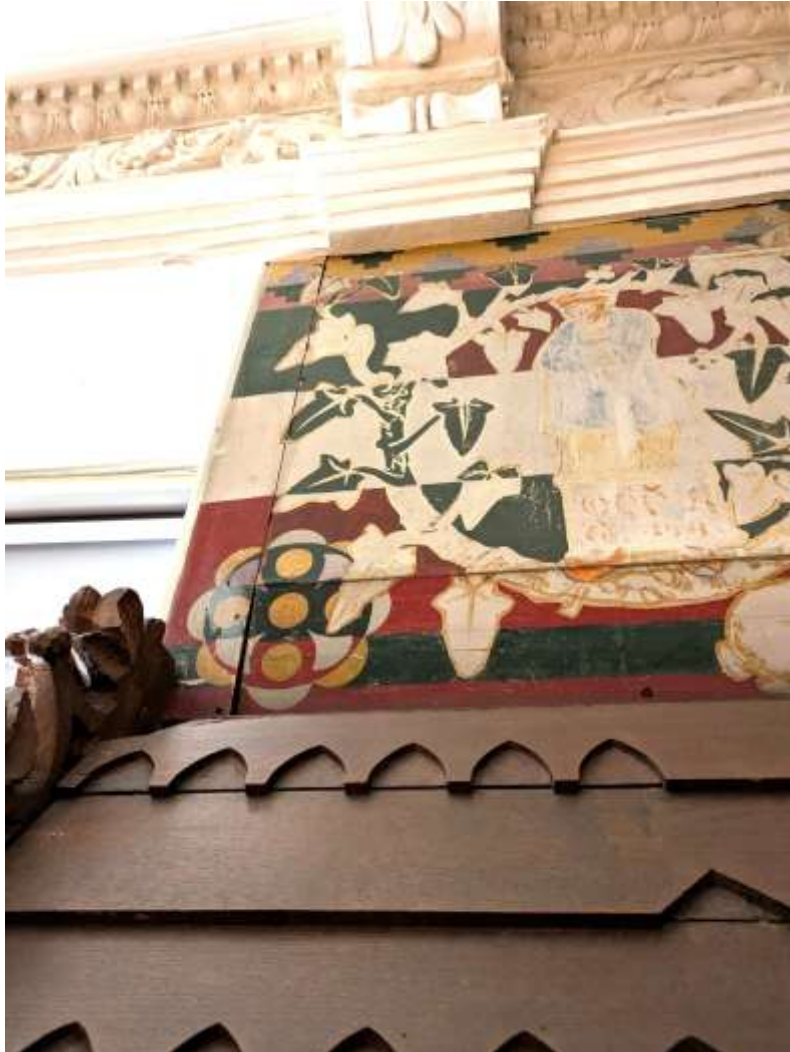
# Understanding Threats: Humidity

■ BLI Brown Drawing Room, Temperature (C)  
■ BLI Brown Drawing Room, Humidity (%RH)
